Fan Pressure Test at 111 and 109 Madison Street

111 Madison Street is right-half of an existing brick building that was fully gutted and rehabbed in 2010. The other half of the building, 109 Madison Street, was renovated in 2007. Each side of the building contains two apartments and a full basement. 111 Madison St was redesigned as part of the NYSERDA Residential Performance Challenge Project.

On May 21, 2010 we conducted a blower door test that simultaneously pressurized both sides of the building in order to separately measure the leakage from each building relative to outdoors. The test conducted by Terry Brennan, Hugh Henderson, and Jeff Cosgrove.

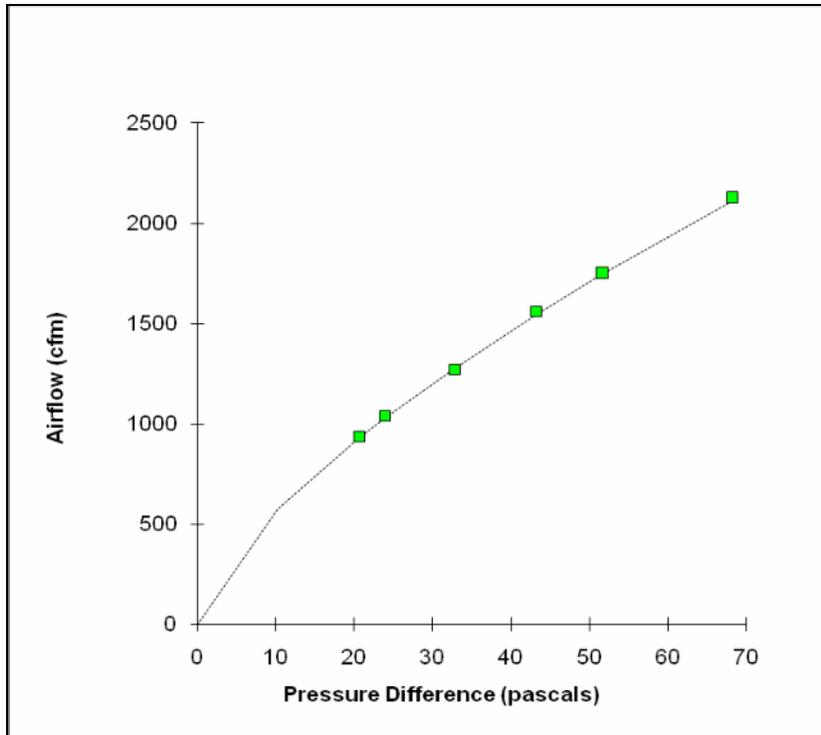
Figure 3. Curve fit of the test for 111 Madison St (New Side)

The new side (111 Madison) had a measured flow of 1707 cfm to outdoors at 50 pascals. The old side (109 Madison) was 1943 cfm at 50 pascals. Curve fits of the data are shown in Figures 3, 4 and 5. Other measures of air tightness are included with the figures. The new side of the building is around 50% leakier than the Energy Efficient Builders Association standard for new buildings of 0.228 cfm per square foot of enclosure at 50 pascals. The old part of the house is 67% leakier than this standard.

C	n
Flow =	116.51	$x \Delta P^{\wedge}$ 0.686 CFM
R sq =	1.000	
ELA4 =	85.51	sq in.
CFM50 =	1706.78	
ACH50pa =	3.29	
m3/hr.50/m2 enclosure =	6.08	
LPS75/m2 enclosure =	2.23	
CFM50/ft2 enclosure =	0.33	
in2ELA/100ft2 enclosure =	1.66

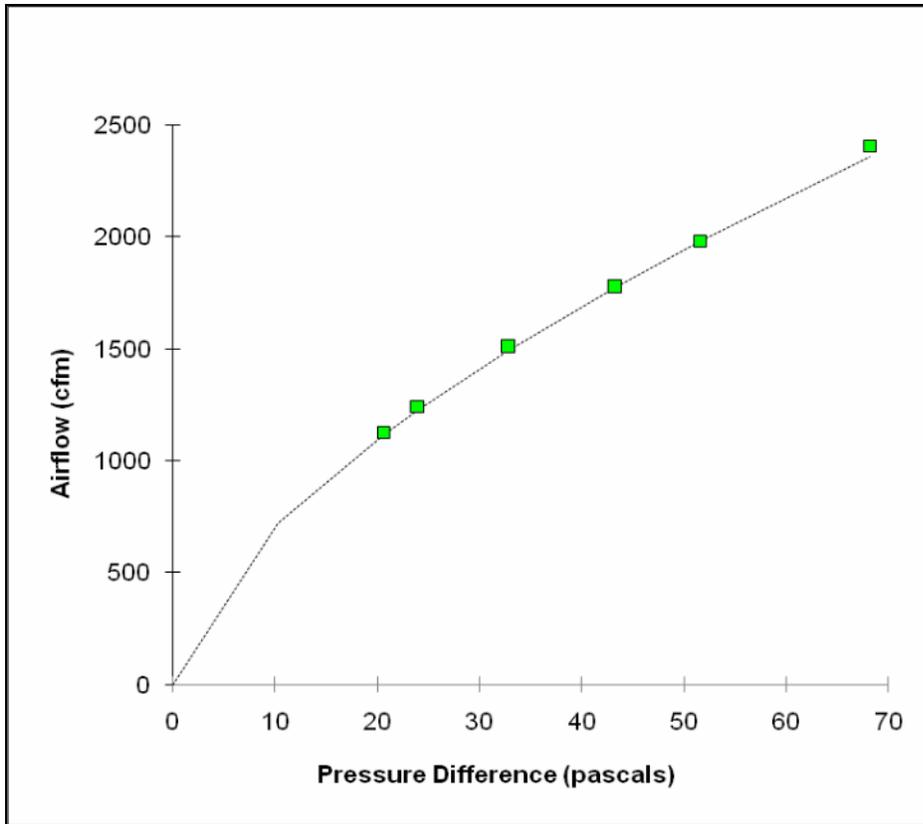
Figure 4. Curve fit for test of 109 Madison St. (Old Side)

C	n
Flow =	168.06	$\times \Delta P^{0.626}$ CFM
R sq =	0.999	
ELA4 =	113.43	sq in.
CFM50 =	1943.17	
ACH50pa =	3.75	
m3/hr.50/m2 enclosure =	6.92	
LPS75/m2 enclosure =	2.48	
CFM50/ft2 enclosure =	0.38	
in2ELA/100ft2 enclosure =	2.21

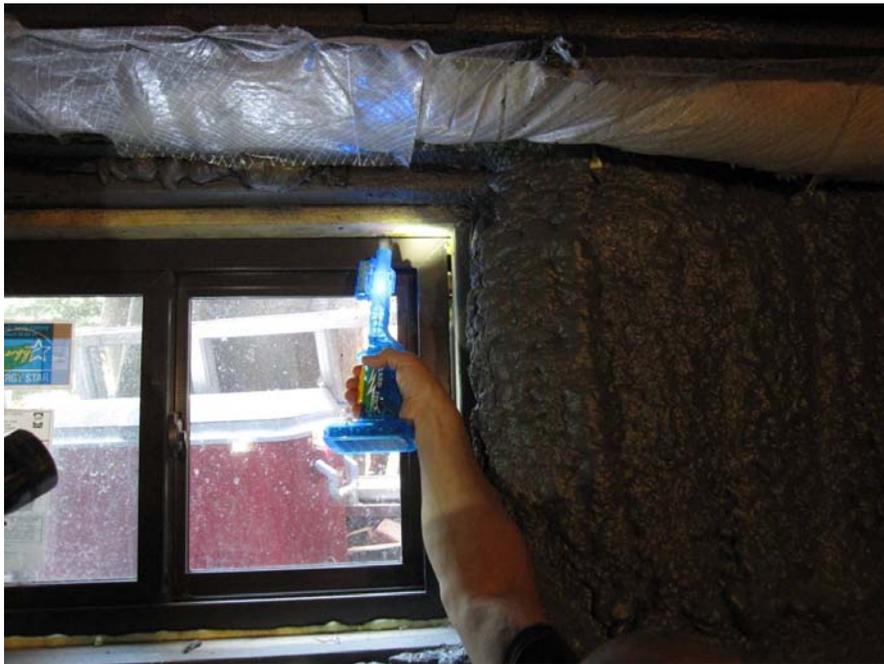
- Crack at top of basement windows
- Beam pocket vents added to ensure floor joists could dry
- 2ns floor attic ceiling including

Figure 6. Air leak at top of window

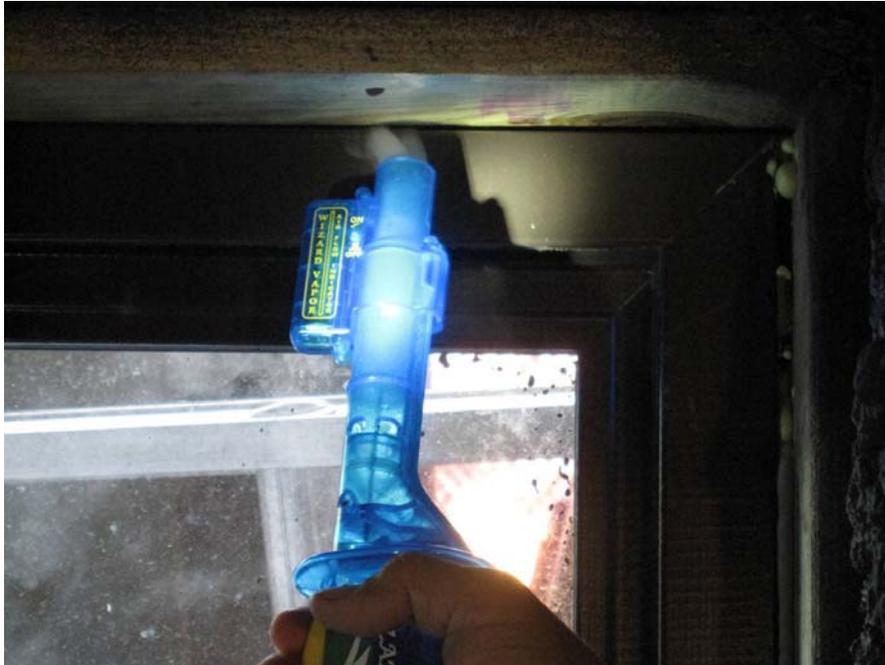
Figure 7. Air leak at top of window

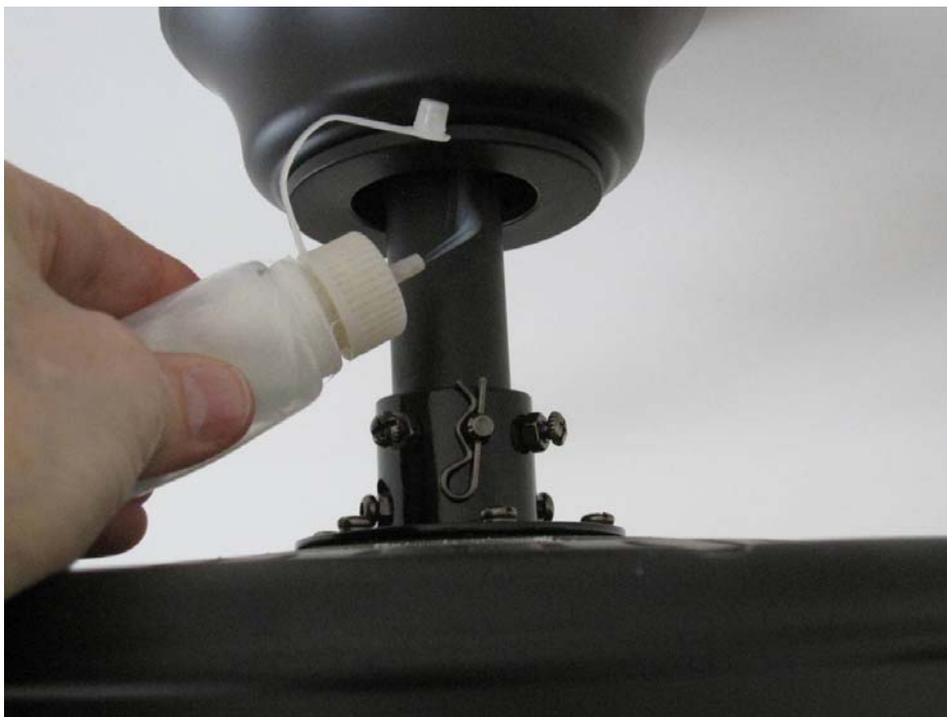
- Interior partitions at outlets and baseboards (through walls into attic)
- Ceiling fan and light fixtures

Figure 8. Air leak at ceiling fan

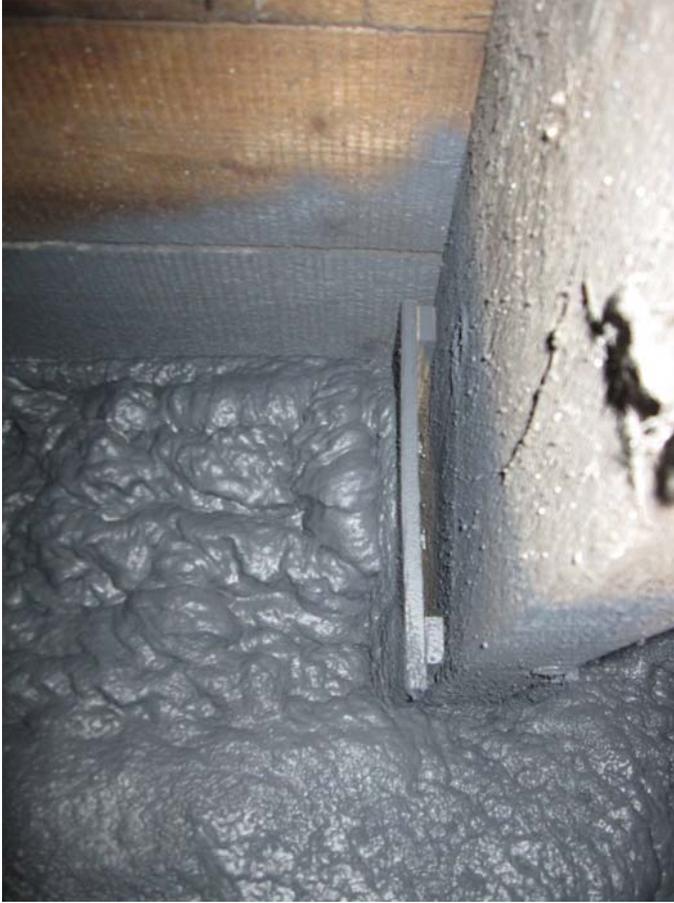
A significant portion of the air leakage in the new side is from the passive vents built around the wooden floor joists where they rest in pockets in the masonry. The original intention of the vents is to improve drying potential and reduce the chance of wood decaying fungi growth in the beam ends (which could cause structural damage). The actual implementation of this design detail was not completed exactly as intended. While this precautionary step was taken due to alleviate concerns that that closed cell foam around the beams would raise the moisture content of the beam in the masonry pocket. However it is not clear whether this precaution was fully necessary. To test this assumption, we plan to make periodic moisture content measurements of the wooden joists in the basement over the course of half a year. Then we will air seal half the joist vents and continue monitoring to determine whether the vents are needed and if needed effective. We will measure the leakage rate through the vents.

Figure 9. Air Leak at "beam pocket" vent
