**FINAL CONSTRUCTION REPORT**

**RESIDENTIAL PERFORMANCE CHALLENGE**

**111 MADISON ST – TROY, NY**

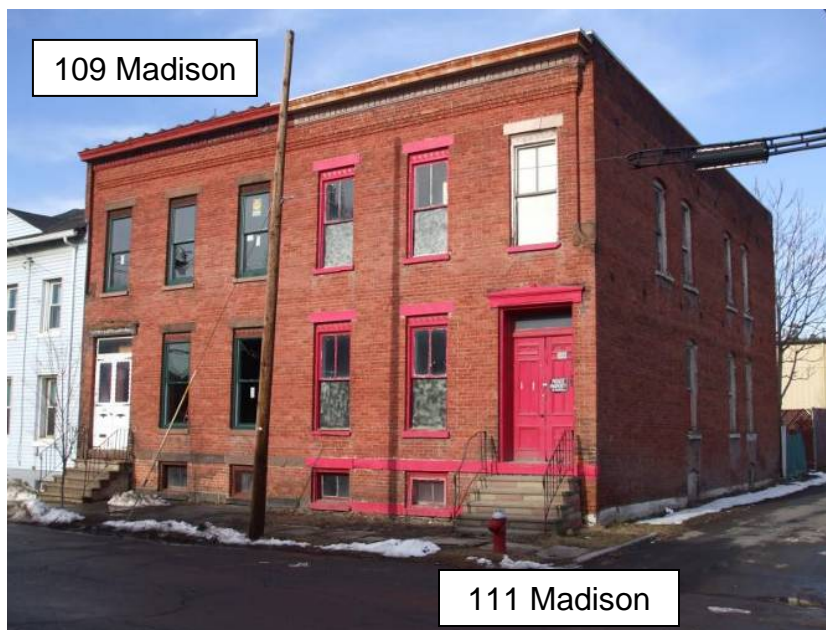
**Figure 1. Photo of Two Buildings**

The right-hand side of this existing building (111 Madison St.) was gutted to the studs and rebuilt in the Spring 2010 by The Madison Project partnership. The left-hand side of the building (109 Madison St.) had been previously gutted and renovated in 2008. This original house was well insulated and constructed to Energy Star Standards. Our goal for 111 Madison was to improve on that original design.

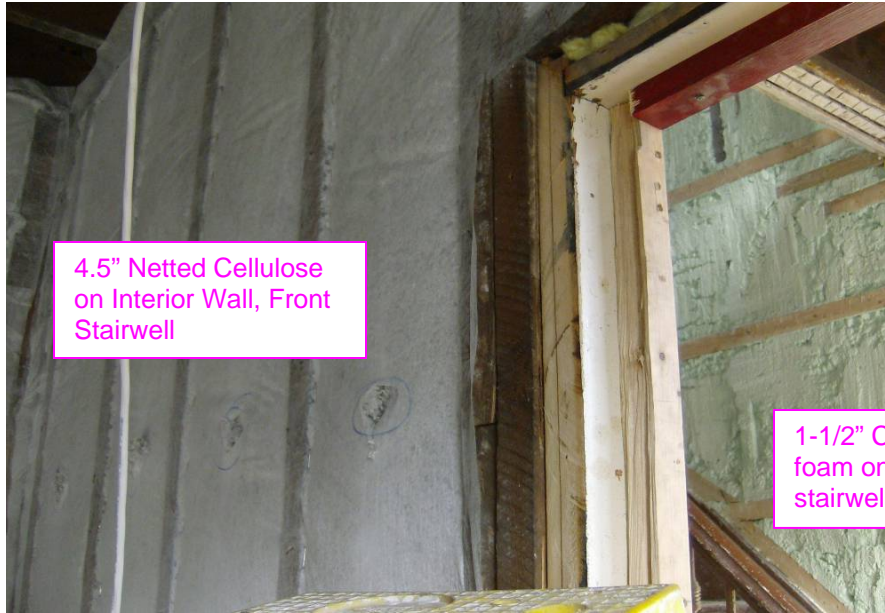
First Floor Front Stairwell

4.5" Netted Cellulose on Interior Wall, Front Stairwell

1-1/2" Closed cell spray foam on exterior wall in stairwell

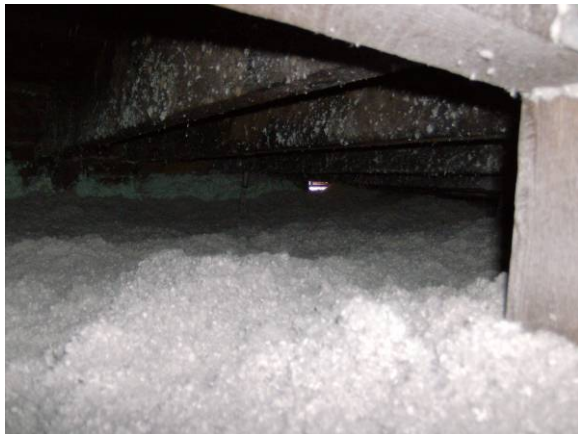
Blown Cellulose in Attic

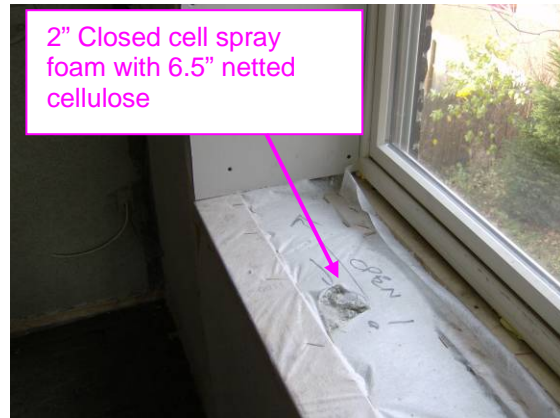
Rear Wall Detail at Window (drywall returns)

2" Closed cell spray foam with 6.5" netted cellulose

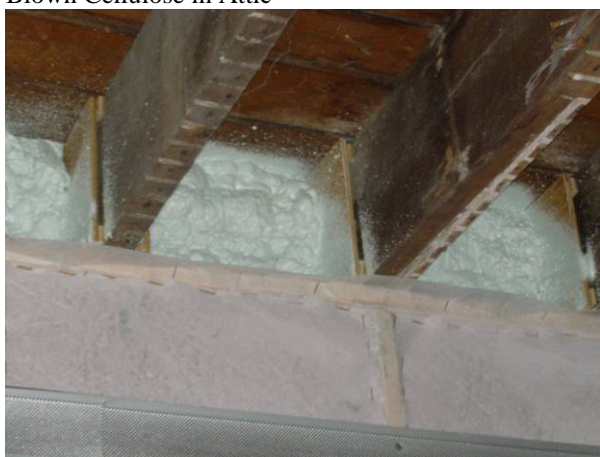
Closed Cell Spray Foam in Rim Joists

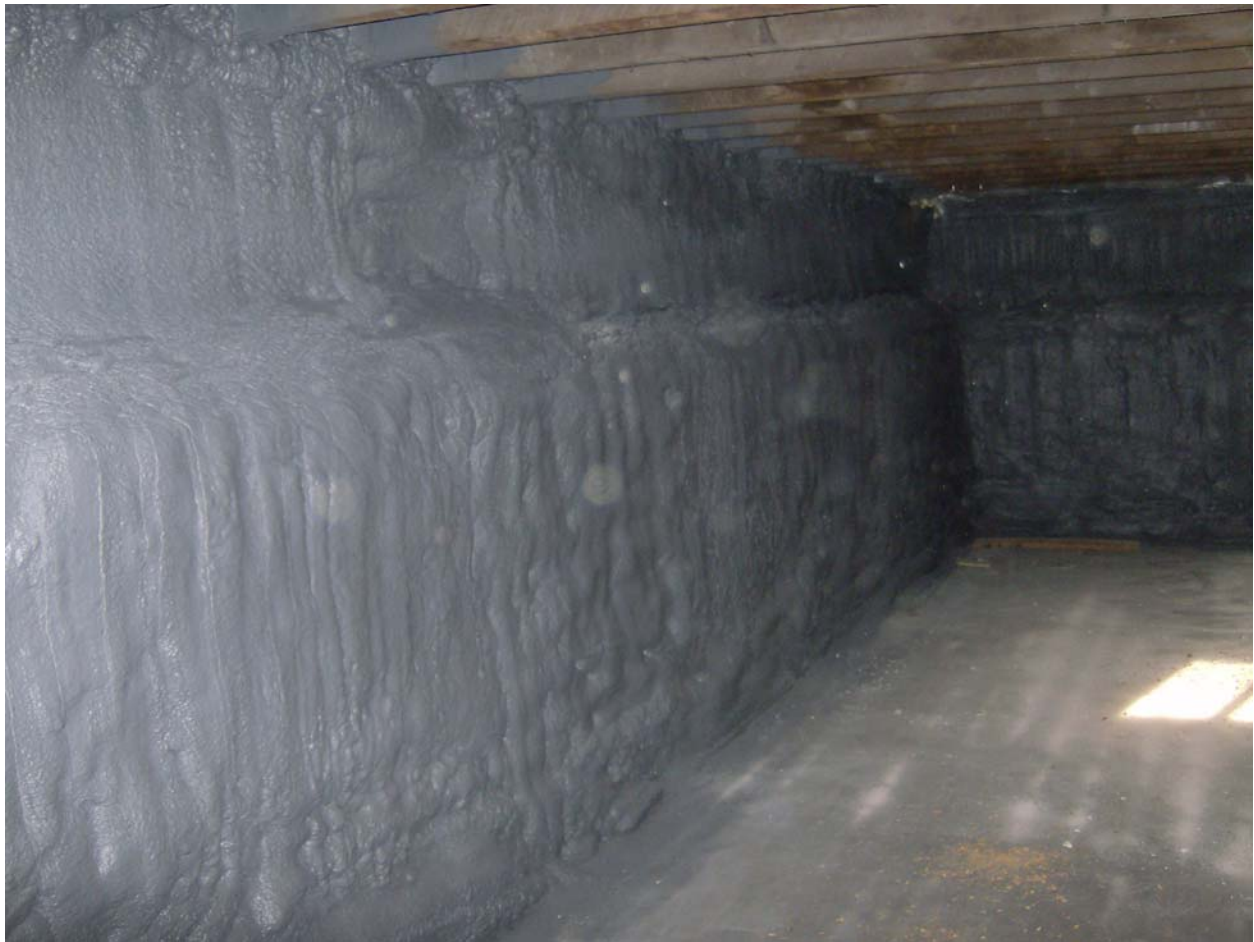
**Figure 4. Closed Cell Insulation on Basement wall with EPDM Membrane on Basement Floor**

The basement floor for 111 Madison St. was covered with an EPDM roofing membrane layed out over the dirt floor, instead of the tradiational poly sheeting covered with layer of stones as was used for 109 Madison St. This apporach provided a cleaner surface in the basement that was easier and cheaper to install. It also provided a better moisture barrier that is more difficult to puncture and if punctured is easier to repair.

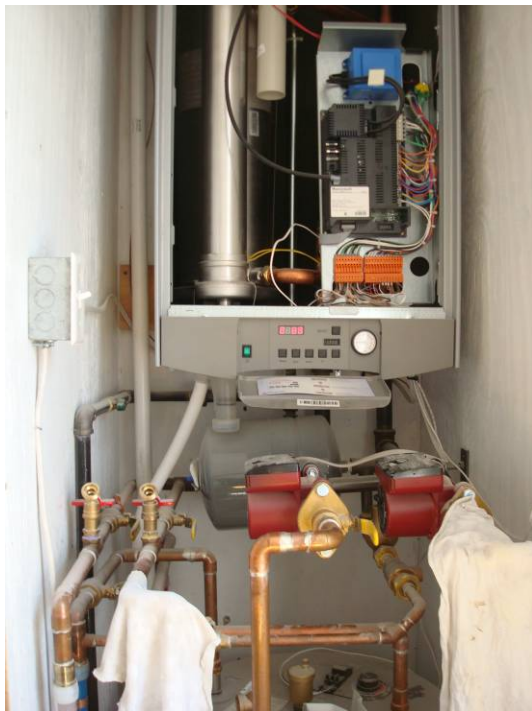
**Wall Hung Boiler located in the Bathroom of each Apartment**

111 Madison used a 95% efficient boiler with a 30 gallon indirect tank in each apartment. The equipment was located near the bathtub. The wall hung boiler is a 60 MBtu/h Prestige (triangle tube) fully condensing water boiler with a Smart 30 tank. Each boiler has a separate circulation pump for space heating and water heating. Space heating is provided by conventional baseboard heaters (36 linear feet upstairs, 33 linear feet downstairs).

The 60 MBtu/h boiler is significantly oversized for the space heating needs of each apartment (about 18 MBtu/h). We worked with the owners and HVAC contractor to develop a lower cost way to heat the two apartments. One option was to have one boiler to serve both apartments (each with their own hot water tank). However this approach was ultimately not used because it was important to maintain separate utility metering for each apartment. We also looked at options that would integrate a hydronic AHU into the water heating system (i.e., the Rinnai AHU), but this concept was not accepted by the site.

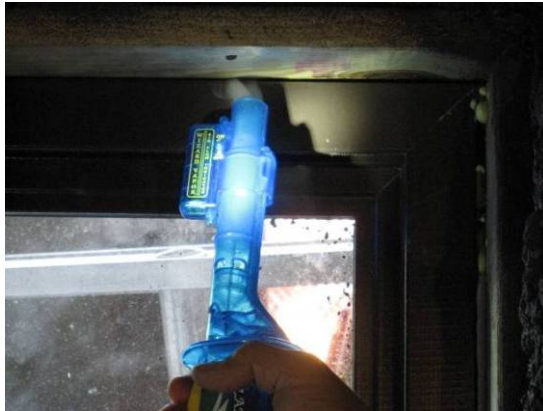
Air leak at top of window

Savings are primarily due to air tightness and added insulation. We performed a blower door test to show the air tightness of both sides of the building. 111 Madison St. was tighter than 109 Madison St. but not as tight as we had anticipated. Smoke bottles were used to identify air leaks in the building as shown below. The results of this test are presented in a separate report.

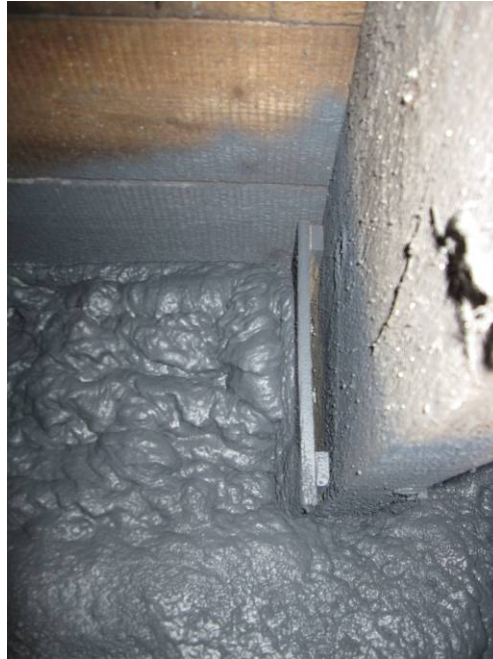
Air pocket at beam pocket vent (for moisture protection)

In addition to energy monitoring, we will take periodic measurements of the moisture content of the various “beam pockets “ to determine if concerns about moisture buildup in the floor joists is warranted.. Camroden will use their handheld moisture meter to check the moisture content throughout the year. These “pockets” which improve drying are also thought to increase air leakage.

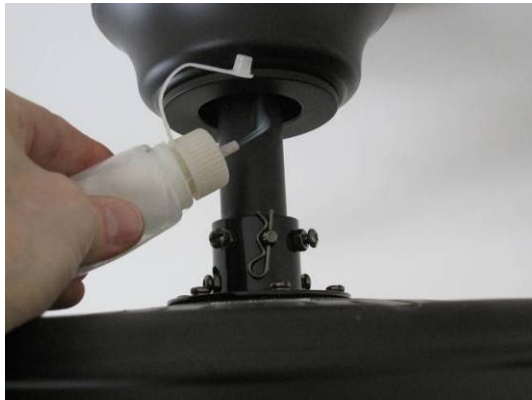
Air leak at ceiling fan

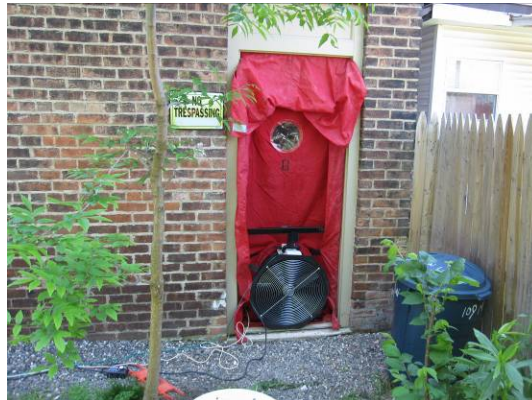
Fan door in old part of building (109 Madison St.)
