FINAL CONSTRUCTION REPORT

RESIDENTIAL PERFORMANCE CHALLENGE

HOUSE #1
113 WOODLAND AVE - HOME HEADQUARTERS

Revised January 2011

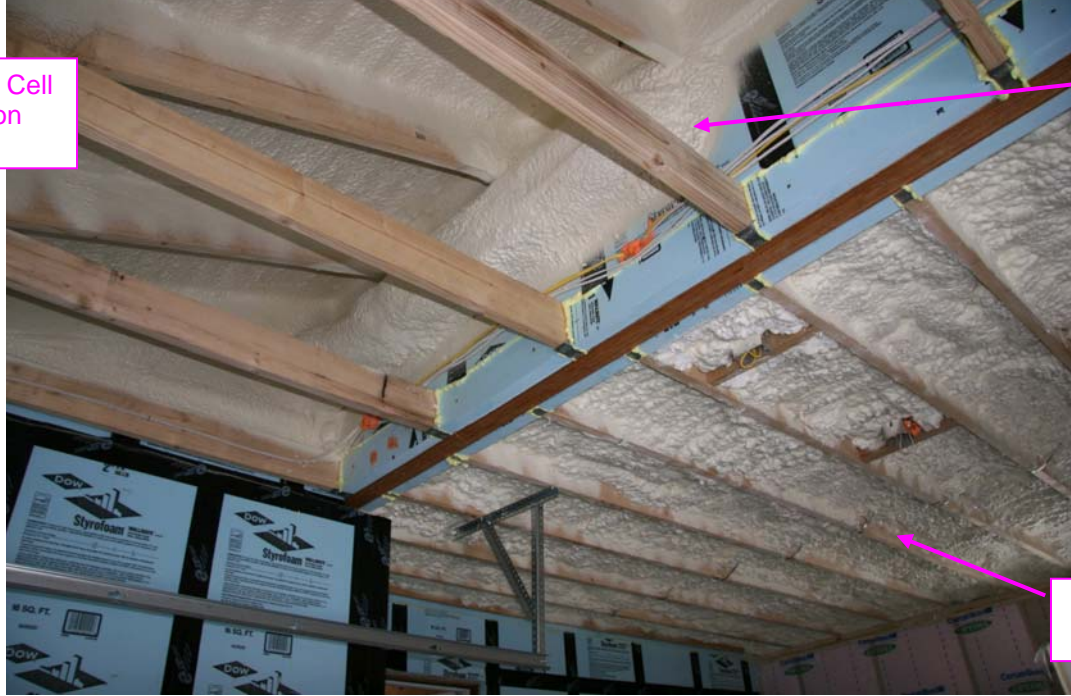
Figure 2. Insulation Shown Inside the Garage (rigid foam applied before drywall)

Closed Cell
Foam on
Roof

Supply
Duct
Encased in
Closed Cell
Foam

Open Cell
Foam

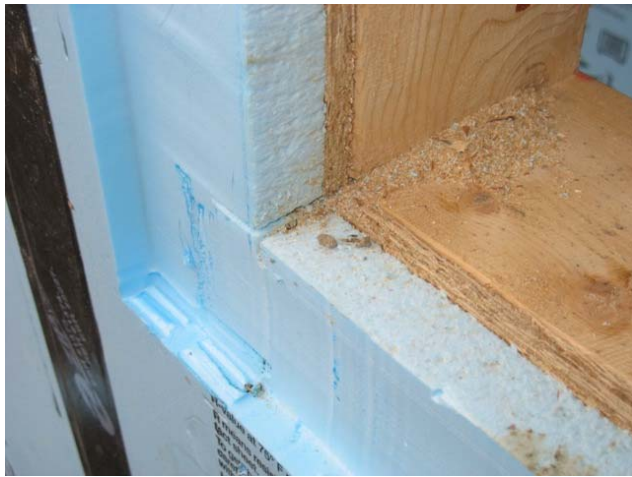
Foam cut back around the window

Figure 3. Details for Installing Exterior Foam

Similarly, they used their lower-cost labor to cut scrap foam pieces left over from the exterior foam installation (see Figure 3) in order to fill in between the rim and band joints (see Figure 4). Then they used cans of spray foam to seal in the pieces. This resulted in a cost-effective means of achieving 4 inches of foam in the rim and band joints while also using up the scrap material and providing good utilization of their lower-skilled staff.

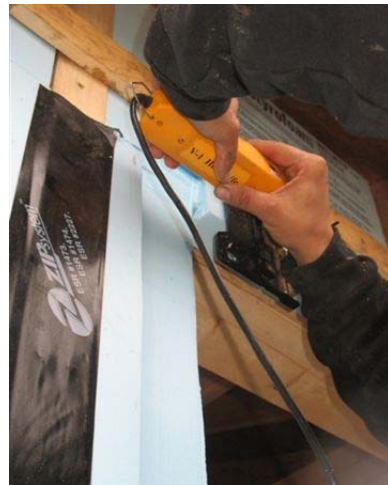
Tool used to cut out foam around the windows

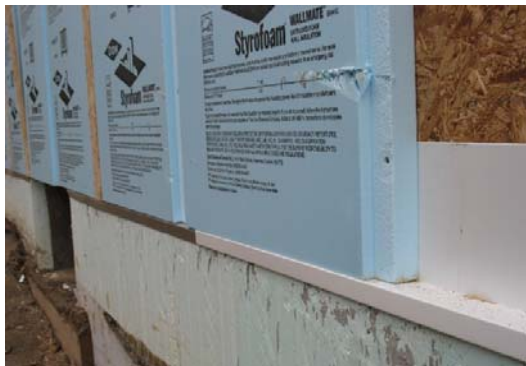
Dow Wallmate with furring strips

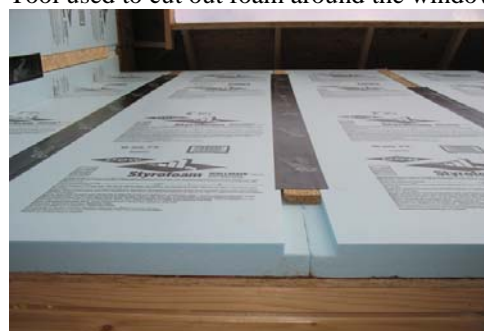
Furring strips with tape applied

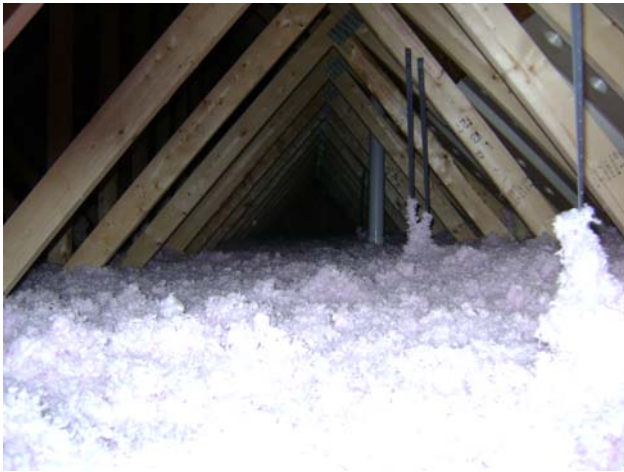
Blown Fiberglass in Attic

Figure 4. Construction Details

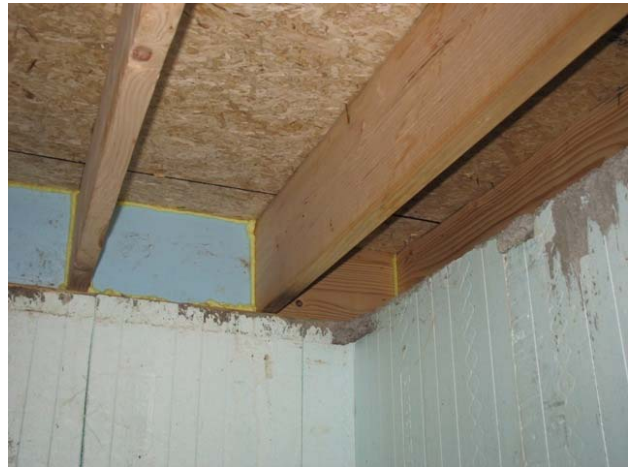
Foam Board Scraps used in Rim Joist

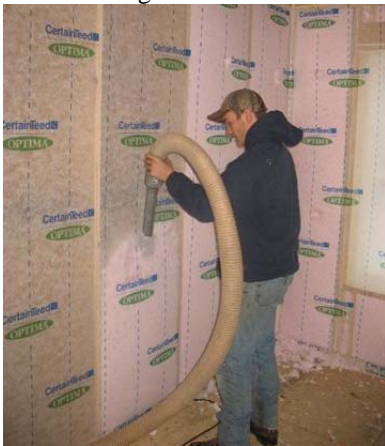
BIBS System in Exterior Wall

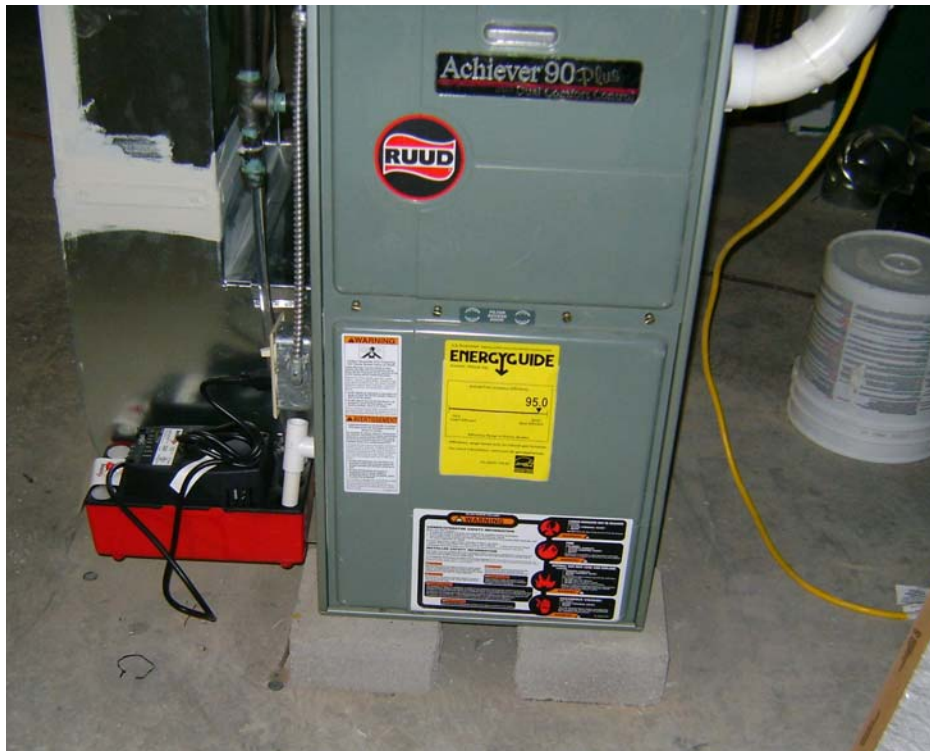
Figure 5. Two-Stage Gas Furnace

The budget for the HVAC contractor was originally set based on a standard condensing furnace. We worked with the HVAC to minimize the supply and return ductwork so that the furnace could be upgraded to a 95% efficient, two-stage 60 Btu/h unit while retaining the same budget. We worked to move many supply grills towards the middle of the house, and minimized the return ductwork by having central return grills in the center of the house (upstairs and down). The reduced sheet metal and ductwork took advantage of the reduced thermal losses and stratification that result from the highly efficient building envelope.

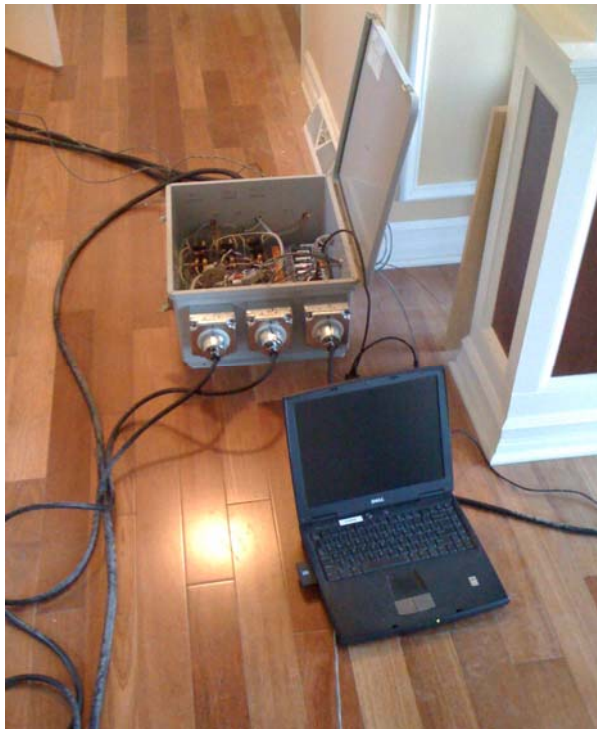
We also completed a Co-Heating test at the house. Electric heaters were controlled to maintain the temperature in house. A datalogger controlled the resistance heaters in three separate zones to maintain the space temperature. The results of this test are presented in a separate report.

Setup for co-Heat Test

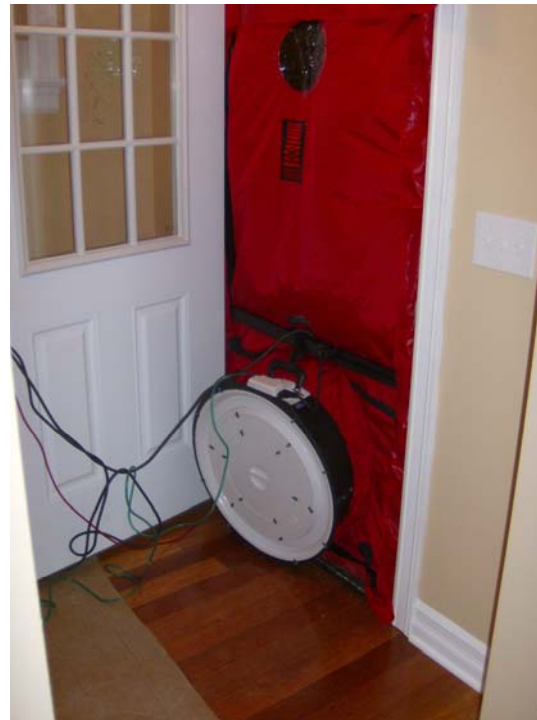
The blower door test found the air tightness to be 2.12 ACH50. A major fraction of the leakage was through the door connecting the house to the garage.

Blower Door Setup
